LPS Bulletin – Reliability

RI-C5 SHU-Feed Pre-heater tube leak 17-Nov-09

IPS Control:
1733108

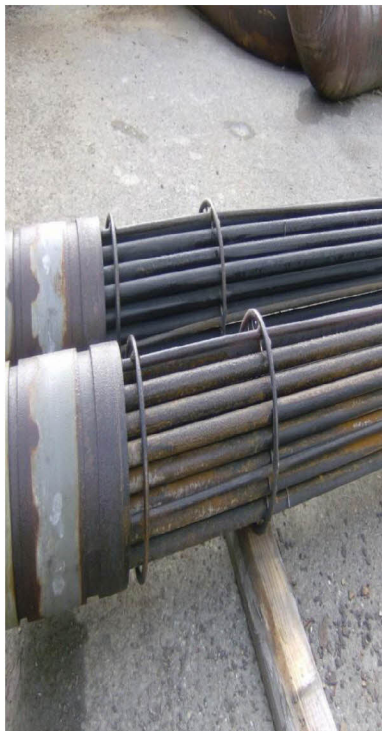
Most severe O₂ pitting on bottom tubes where condensate exits shell side of exchanger

1. E-901 was discovered to be leaking internally to the condensate system and was vaporizing in the condensate flash vessel which ultimately vents to the atmosphere.
2. E-901 Internal inspection revealed a tube failure and allowed the higher pressure process to leak into the condensate. The original bundle (15 years service) was found externally pitted at the steam/condensate interface with extensive corrosion.
3. The external tube corrosion mechanism was related to oxygen pitting as the 150 steam is shell side inlet and condensate on the shell outlet. A low concentration of oxygen can always be present in the 150# steam header. Over time, this can lead to pitting in steam supplied equipment.

1. Four tubes were plugged and unit was placed back in service. 1/15/2010 - Tube bundle was replaced in-kind with new unit during planned Alky plant pit stop.
2. The cost of implementing a design change is greater than replacing the existing bundle every 15 years.
